Buttress Dams

Best Practices in Dam and Levee Safety Risk Analysis

Part E – Concrete Structures

Chapter E-5

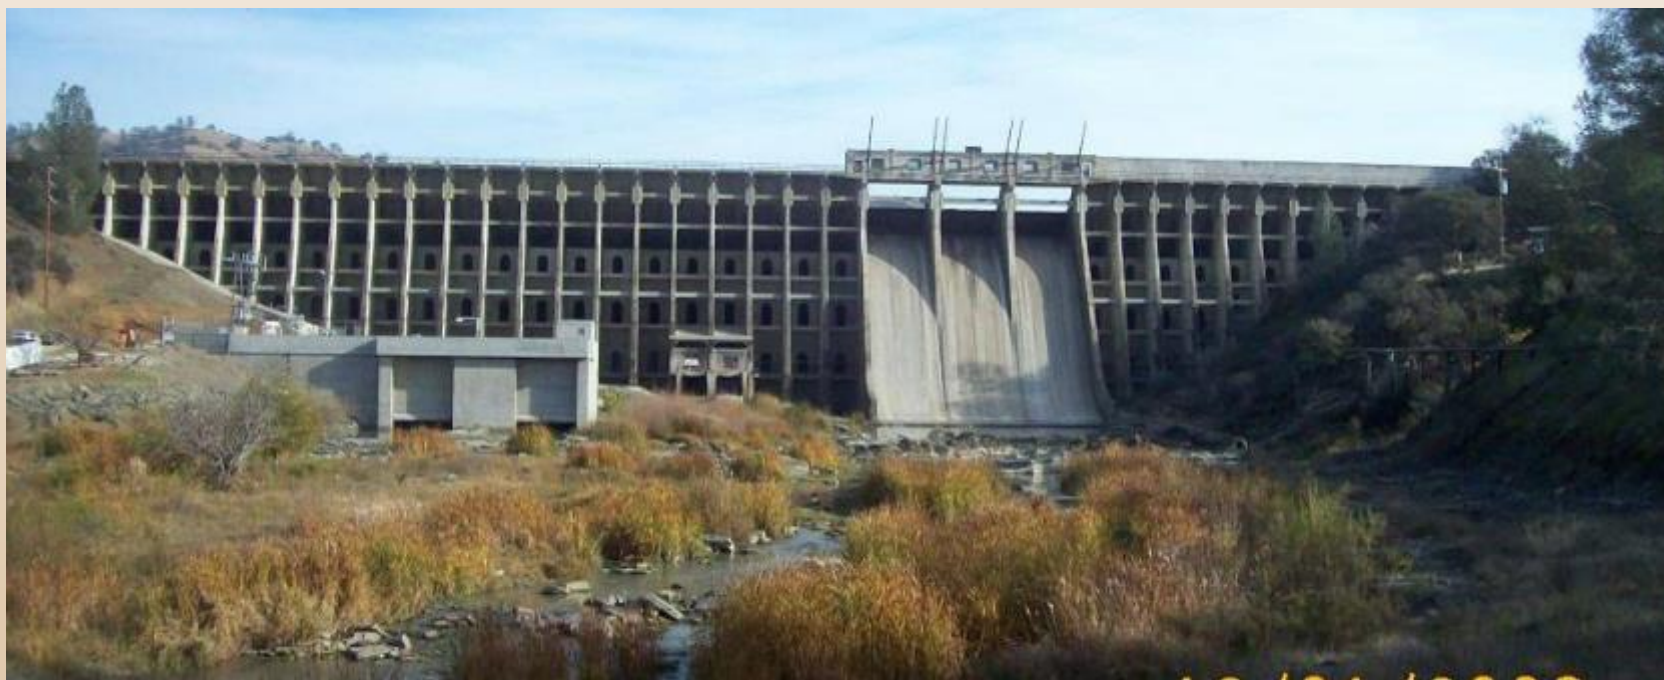
Slab and Buttress

Also known as an Amburesen Dam

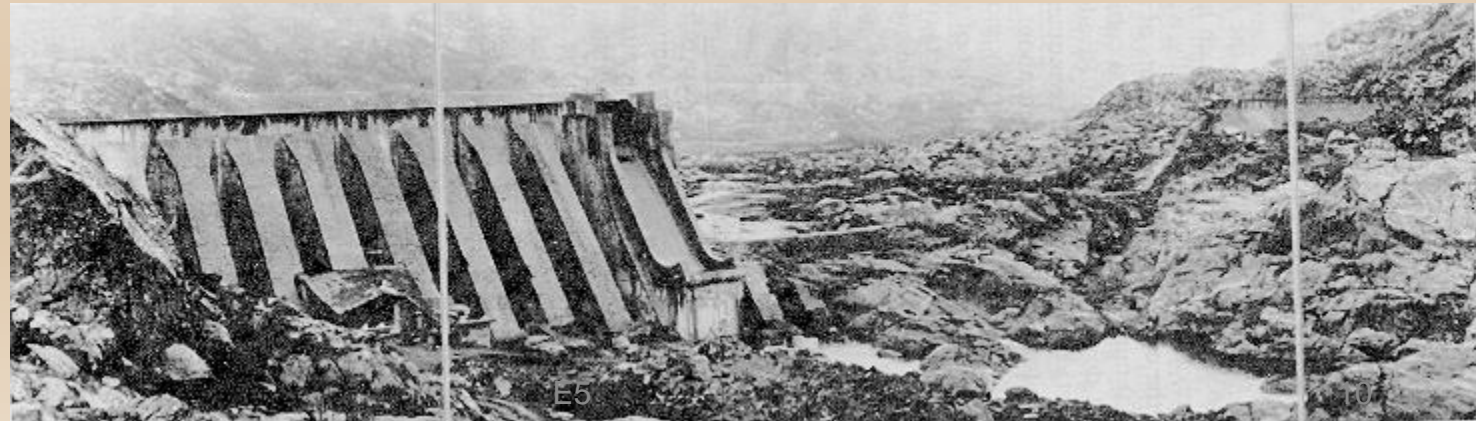
Vega de Tera Dam, Northwest Spain

112' high buttress dam
completed 1957

Winter shutdown, little
attention to lift joints

Failed January 10, 1959

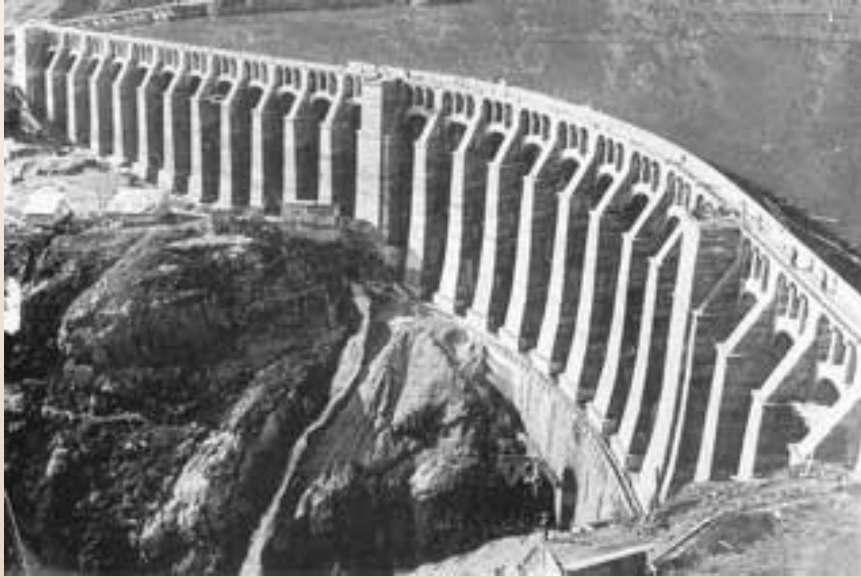
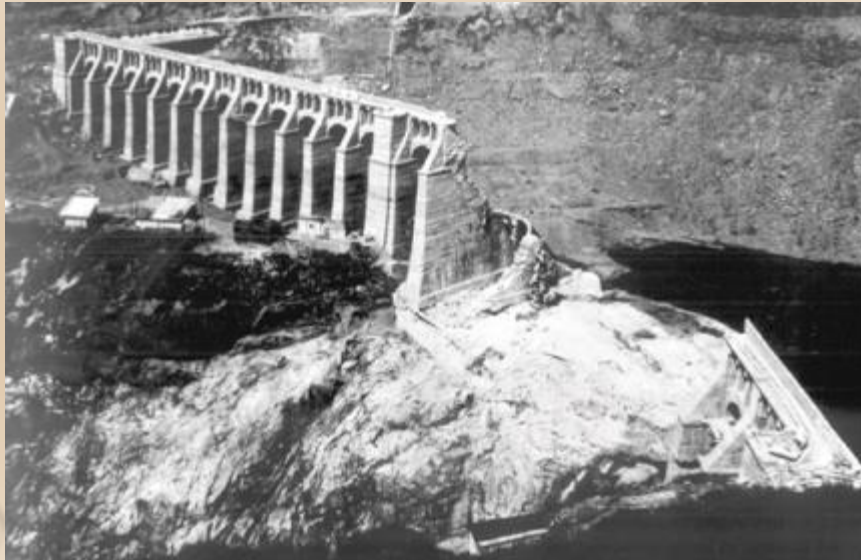
Gleno Dam, Italy

- 164-ft high multiple arch
- 52-foot high masonry plug constructed in deep central gorge (lime mortar instead of specified cement mortar)
- Original design called for gravity dam; design changed and dam built prior to approval
- Poor concrete quality
- Dam survived nearly full for 2 months
- Failed October 22, 1923
- 100-foot high wave, widespread destruction in Dezzo River Valley
- 356 fatalities

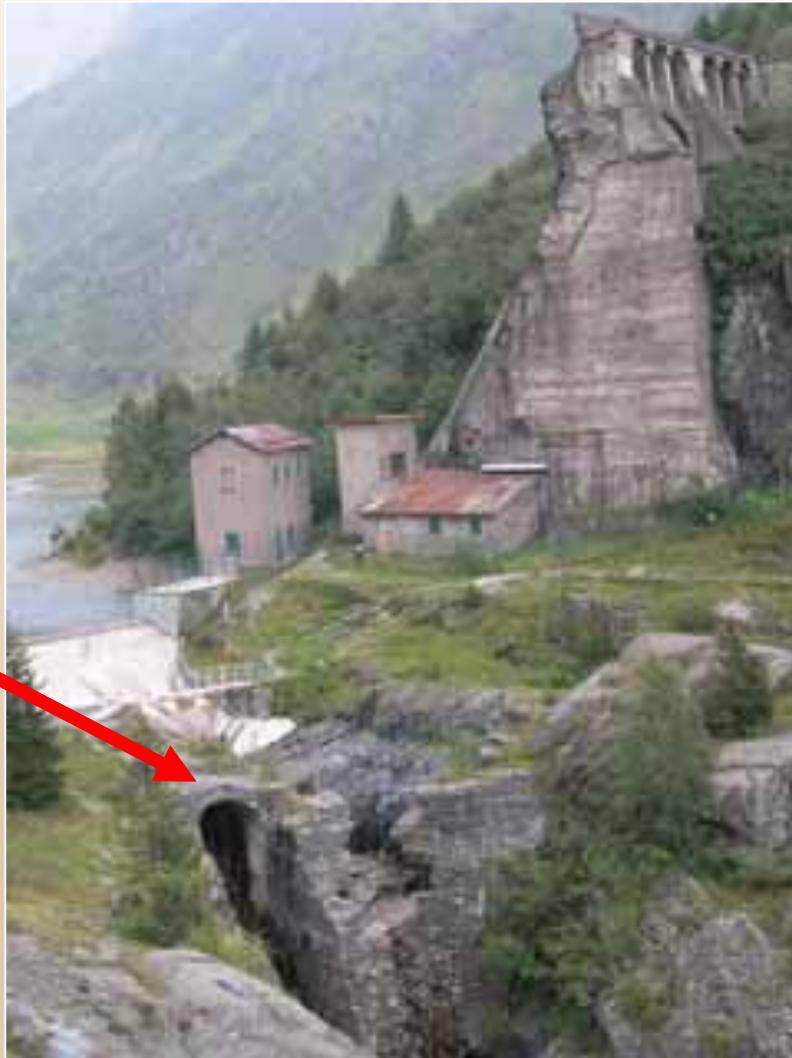
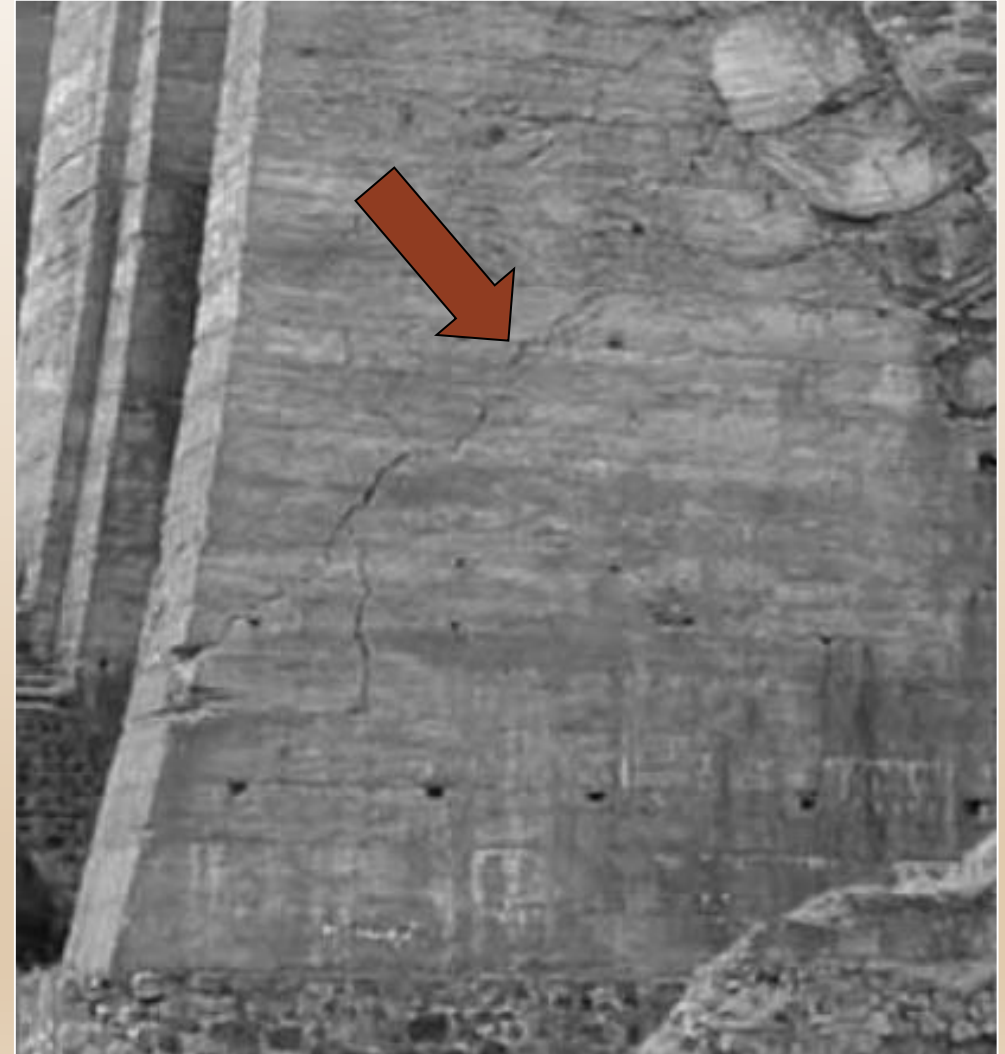
Gleno Dam

Masonry
Plug

Model predicted cracking
matched observed cracking

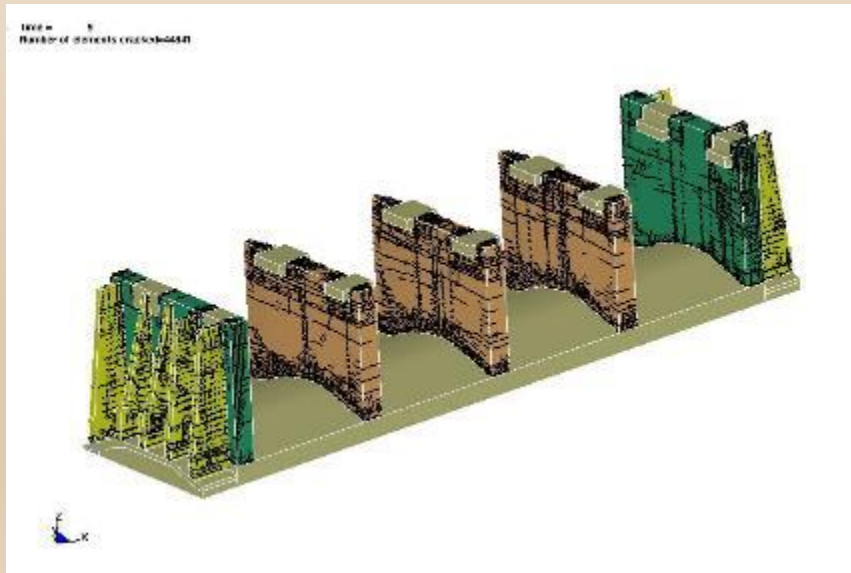
Nonlinear Structural Analysis

- Some nonlinear finite element programs have concrete cracking and steel reinforcement models that can be used to examine the potential for cracking, yielding, excessive deformation and failure directly. However, remember these are just models and careful scrutiny of the input assumptions and output is necessary.
